Fort Monmouth Economic Revitalization Planning Authority

Sanitary Sewer System Evaluation – Status Report

Wednesday, June 17, 2009

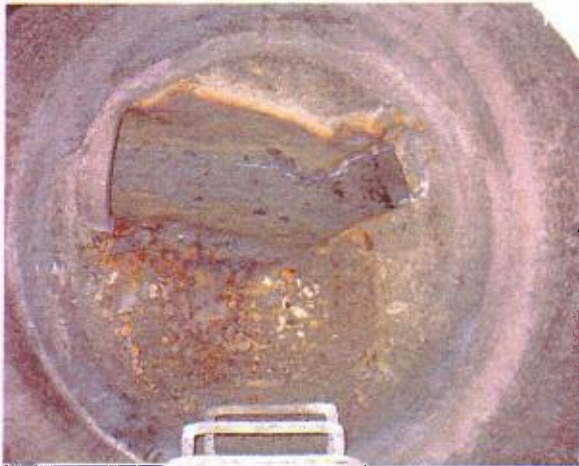
Charles Wood – MH 1A (Guam Lane ROW)
Minor hydrogen sulfide (H₂S) corrosion observed on manhole walls and riser.

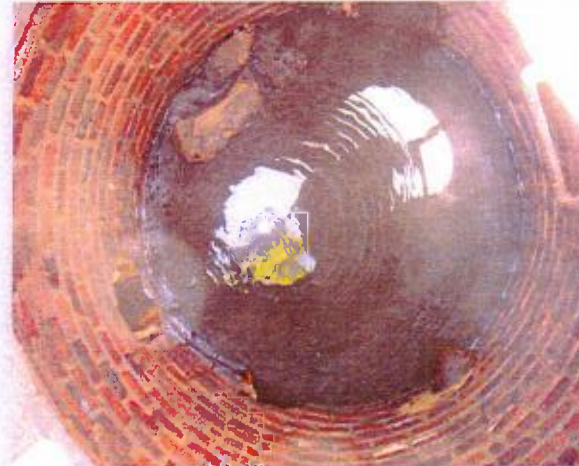
Charles Wood – MH 9 (Guam Lane)
View of 4-inches stagnant flow. Manhole appears to have no channel.

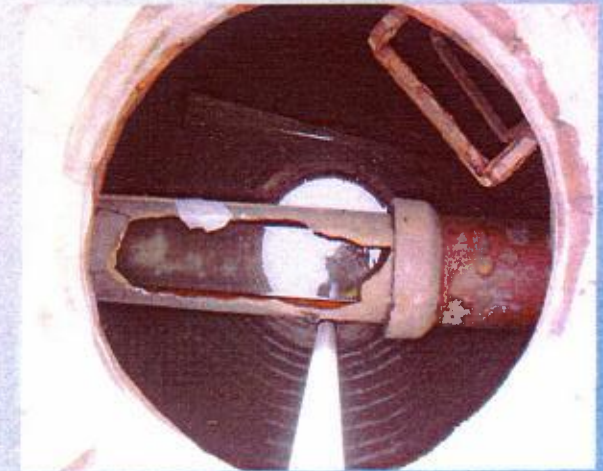
Charles Wood – MH 23 (Heliport ROW)
View of doghouse manhole with unenclosed pipe. Survey rod used to measure 12-inches of stagnant flow.

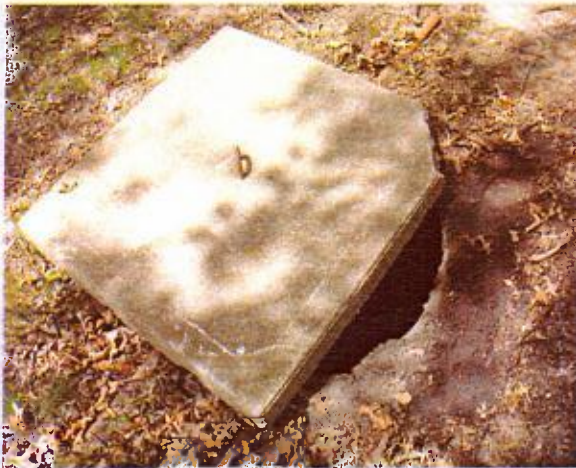
Main Post – MH 15A (Barkers Circle)
View of concrete slab placed over manhole; no frame or rim on manhole. HMM unable to remove slab.

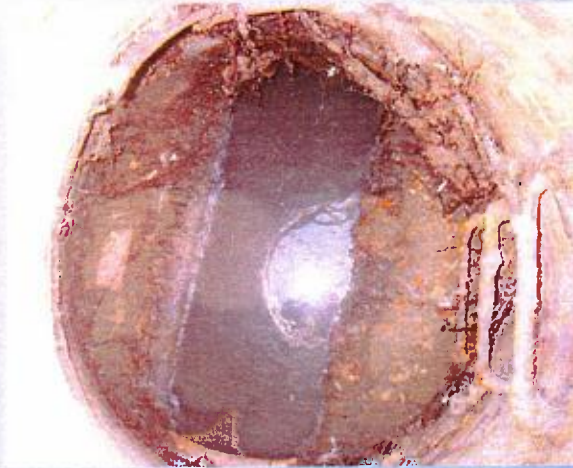
Main Post – MH 68 (Parkers Creek ROW)
View of large root throughout manhole protruding from lower wall.

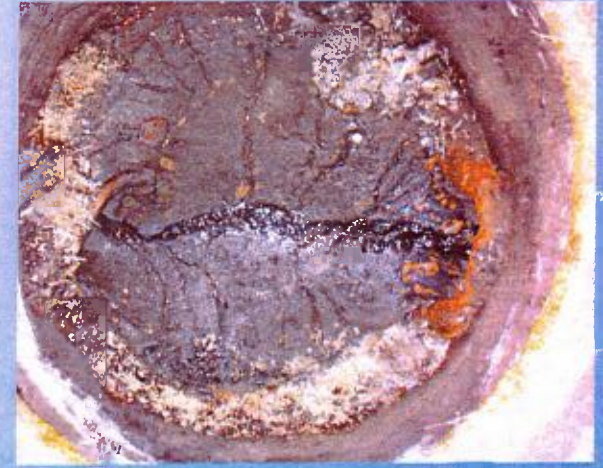
Main Post – MH 144 (Sherrill Avenue)
View of significant hydrogen sulfide (H₂S) corrosion throughout manhole.

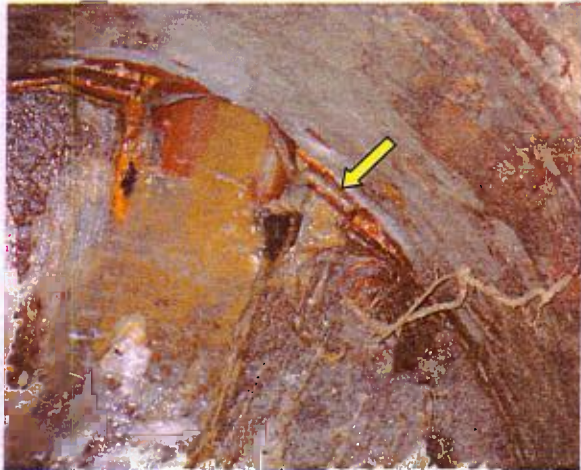
Charles Wood – MH 44B (Hemphill Road)
Arrow points to estimated 2 gpm (3,000 gpd) wall leak to right of effluent pipe. Minor root intrusion from wall / bench junction.

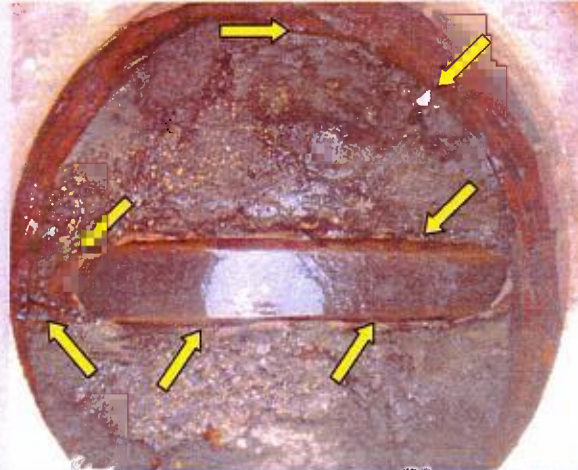
Charles Wood – MH 14 (Satellite Road ROW)
Arrows point to estimated 7 gpm (10,100gpd) from both pipe sleeves, wall / bench junction and benching.

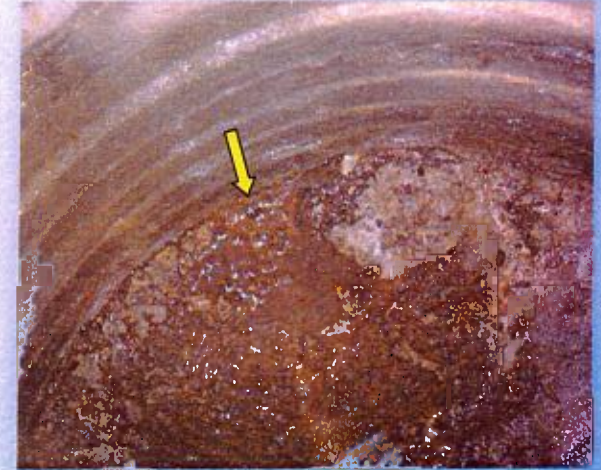
Charles Wood – MH 46 (Corregidor Road)
Arrow points to estimated 3 gpm (4,300 gpd) from wall and bench junction.

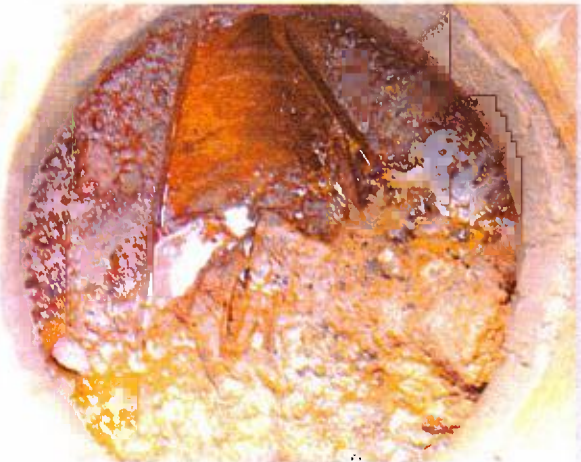
Main Post – MH 9E (Riverside Avenue)
Estimated 2 gpm (3,000 gpd) from caps of both pipes.

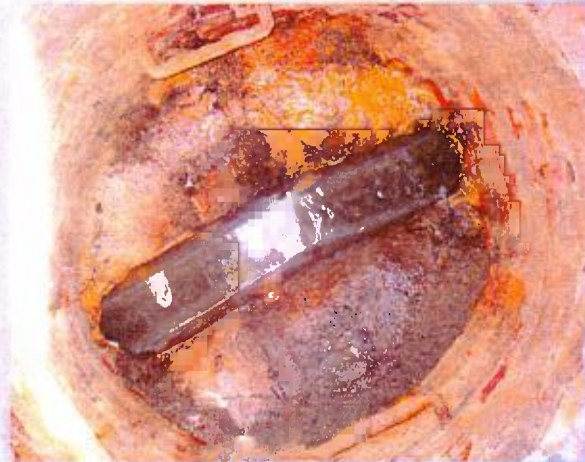
Main Post – MH 21 (Barkers Circle)
Estimated 2 gpm (3,000 gpd) from sleeve of effluent pipe, benching, and wall and bench junction.

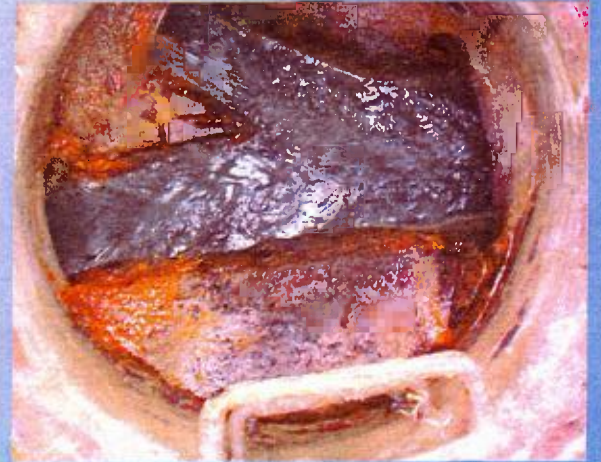
Main Post – MH 59 (Allen Court)
Estimated 1 gpm (1,500 gpd) from the sleeves of both influent pipes.
