Fort Monmouth Economic Revitalization Planning Authority

Sanitary Sewer System Evaluation – Draft Final Report

Wednesday, August 19, 2009

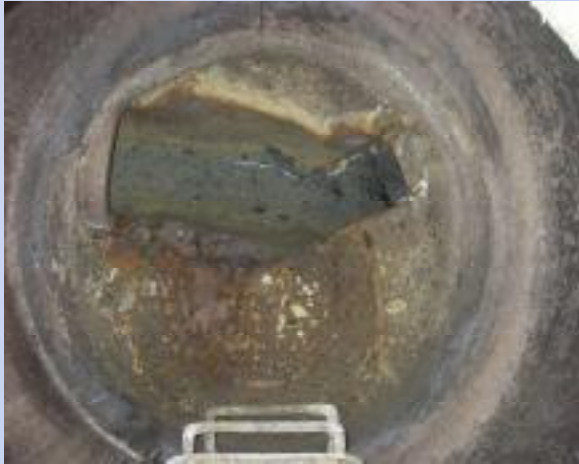
Charles Wood – MH 1A (Guam Lane ROW)
Minor hydrogen sulfide (H₂S) corrosion observed on manhole walls and riser.

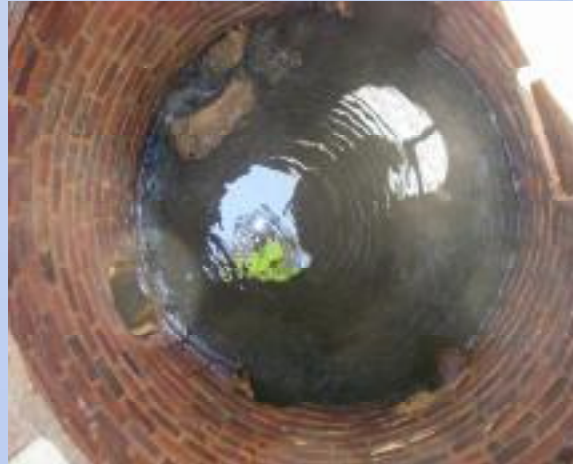
Charles Wood – MH 9 (Guam Lane)
View of 4-inches stagnant flow. Manhole appears to have no channel.

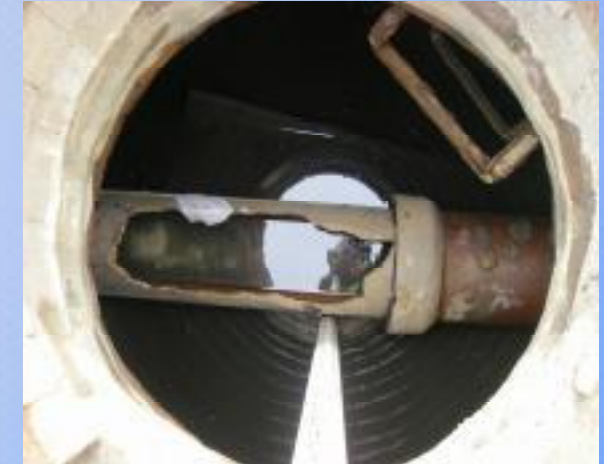
Charles Wood – MH 23 (Heliport ROW)
View of doghouse manhole with unenclosed pipe. Survey rod used to measure 12-inches of stagnant flow.

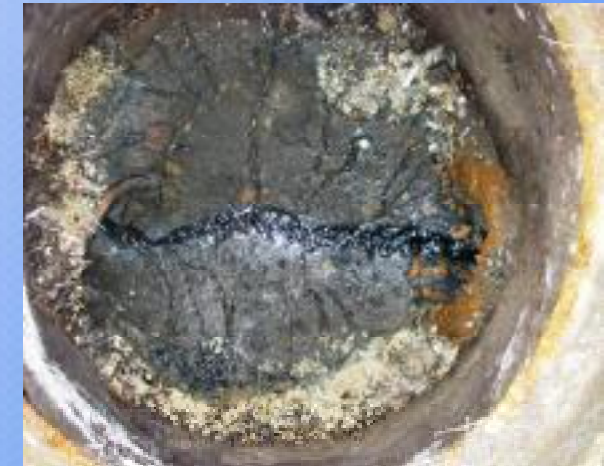
Main Post – MH 144 (Sherrill Avenue)
View of significant hydrogen sulfide (H₂S) corrosion throughout manhole.

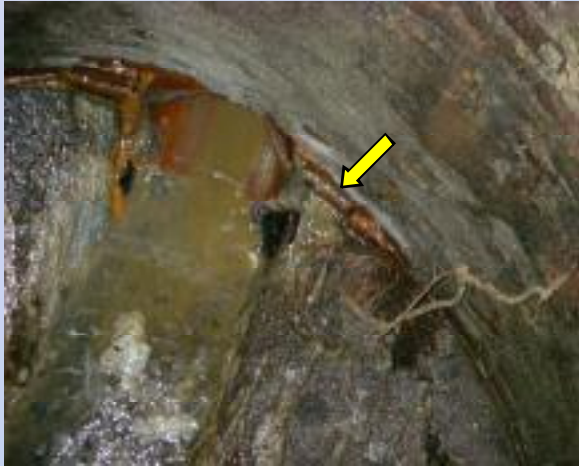
Charles Wood – MH 44B (Hemphill Road)
Arrow points to estimated 2 gpm (3,000 gpd) wall leak to right of effluent pipe. Minor root intrusion from wall / bench junction.

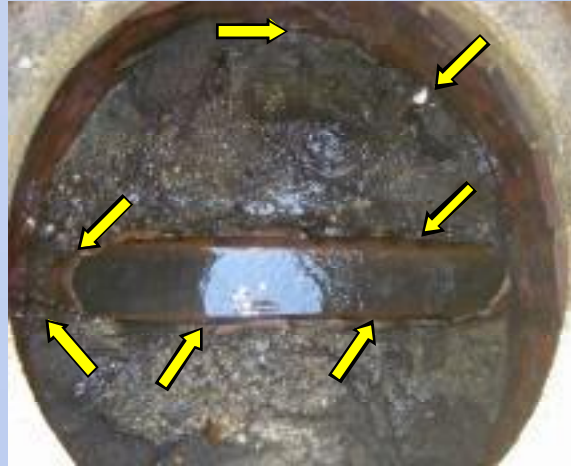
Charles Wood – MH 14 (Satellite Road ROW)
Arrows point to estimated 7 gpm (10,100 gpd) from both pipe sleeves, wall / bench junction and benching.

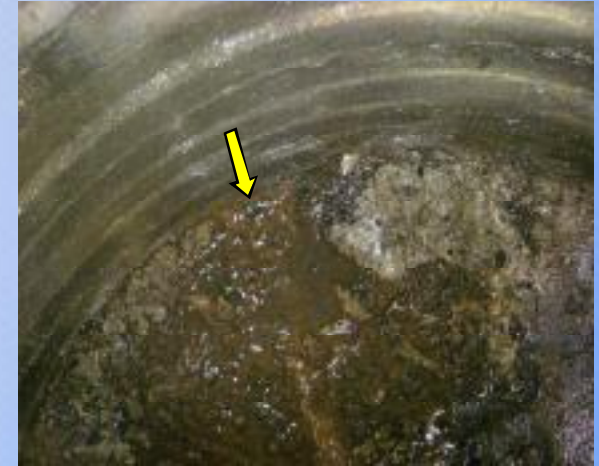
Charles Wood – MH 46 (Corregidor Road)
Arrow points to estimated 3 gpm (4,300 gpd) from wall and bench junction.

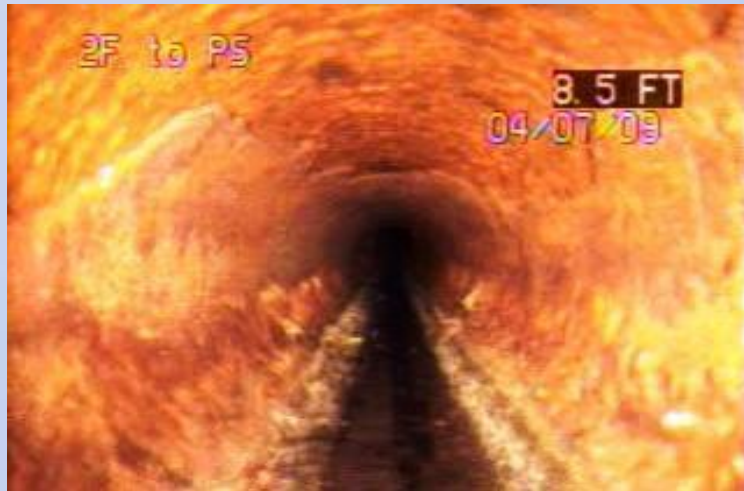
MH 2F to PS - Club House Area
Grade 3 to 4 Hydrogen sulfide corrosion throughout sewer.

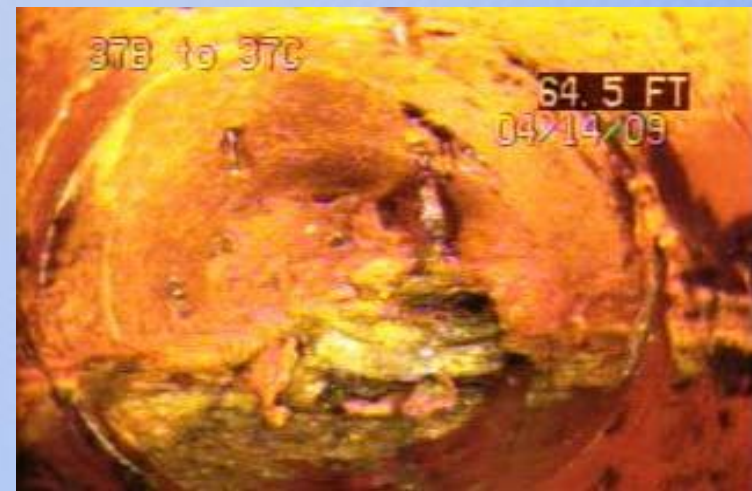
MH 37C to 37B - Building 2700 Easement
Collapsed pipe 64.5 LF from MH 37B.

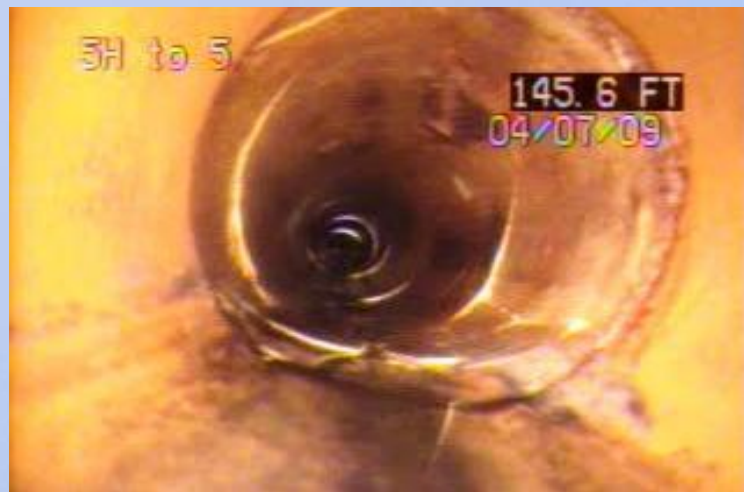
MH 5H to MH 5 - Megill Circle
Grade 4 fractured pipe section 145.6 LF from MH 5H.

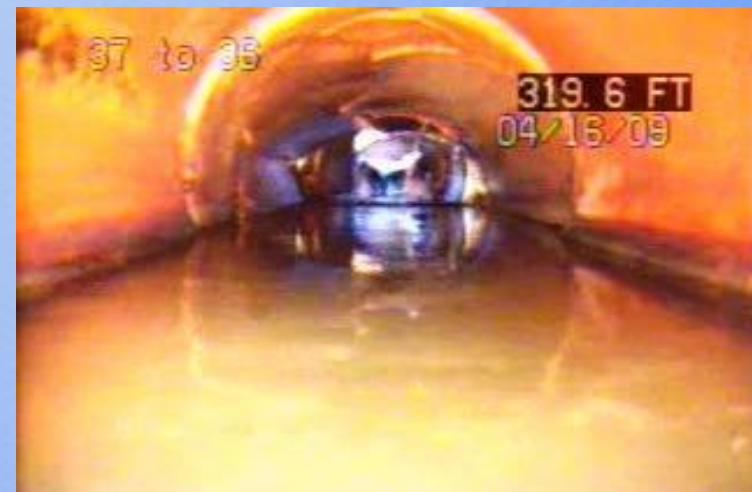
MH 37 to MH 36 - Building 2700 Watson Road
Grade 4 broken and collapsing pipe section with leak.

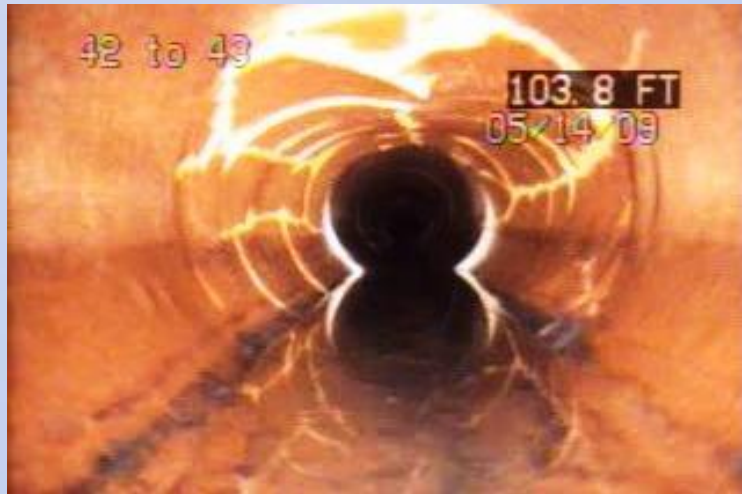
MH 42 to MH 43 - Apex Avenue
Grade 4 fractured pipe section with 15% loss of ovality.

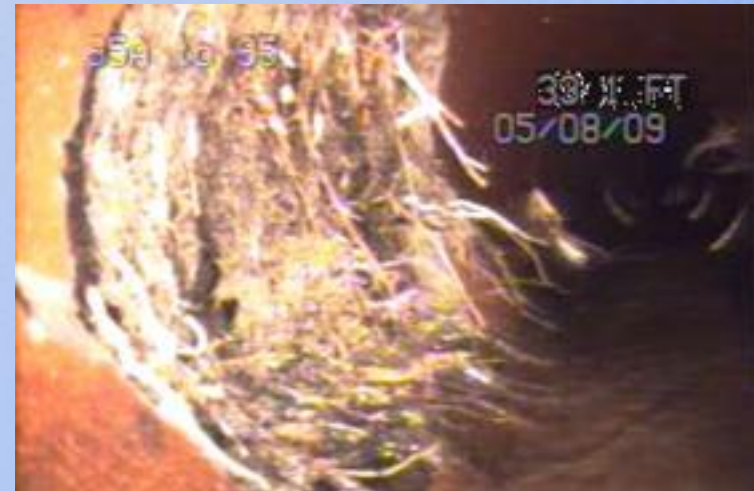
MH 95A to MH 95 - Building 1075
Grade 4 hole with root mass protruding through.

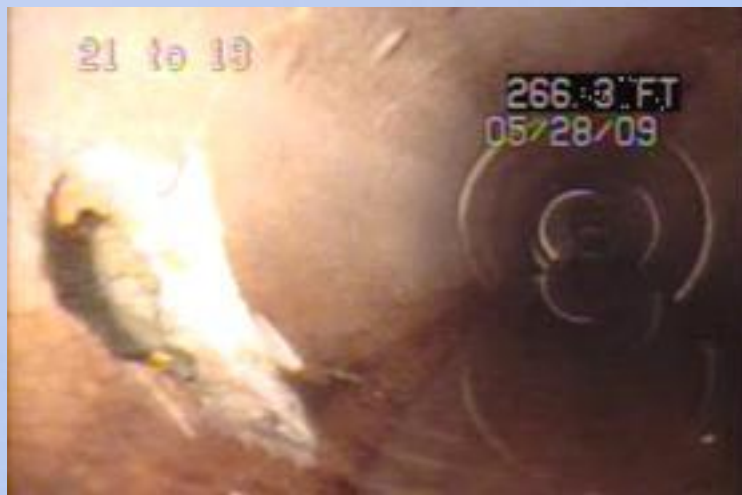
MH 21 to MH 18 - 1st Avenue
Grade 5 hole with outer soil and rocks visible.

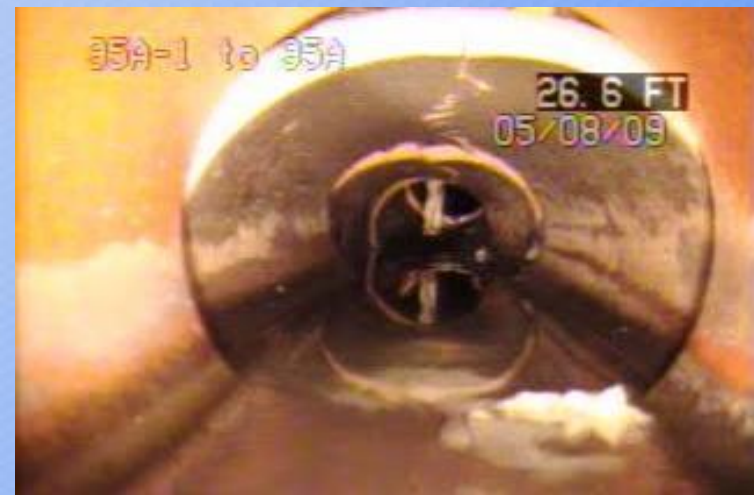
MH 95A-1 to MH 95A - Building 1075
Pipe deformed 20%.

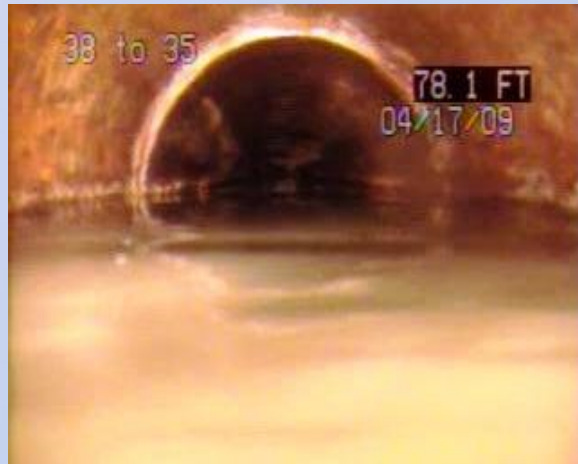
MH 38 to 35 – BLDG 2700 Watson Road
50% backwater condition in pipe due to offset joint further downstream.

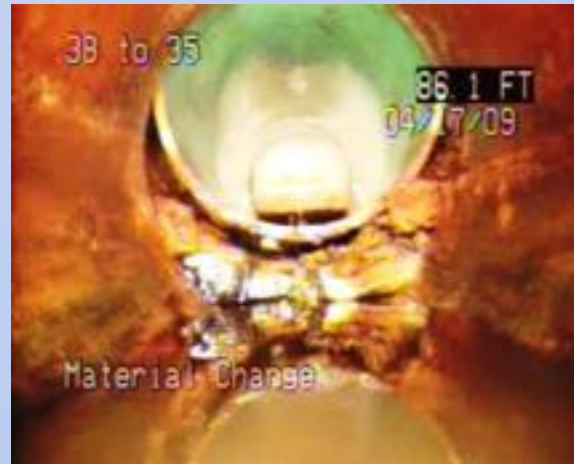
MH 38 to 35 – BLDG 2700 Watson Road
Joint offset 1.5-inches 86.1 LF from MH 38 causing 50% backwater condition in pipe.

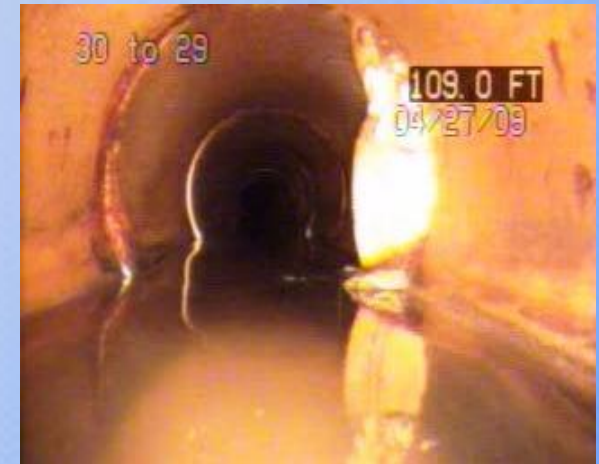
MH 30 to 29 – BLDG 2700 Easement
PBSC protruding 2-inches into mainline 113 LF from MH 30.

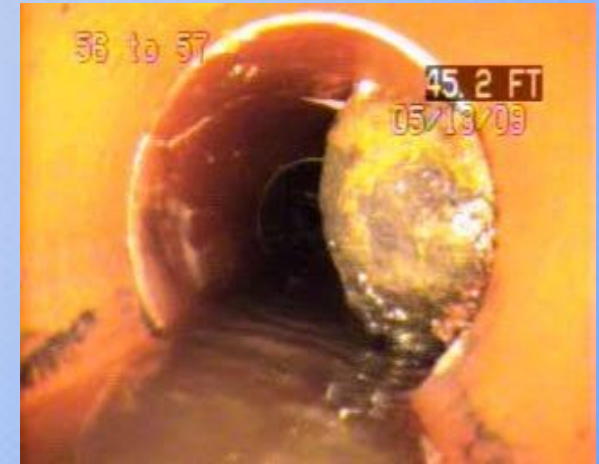
MH 56 to 57 – Signal Avenue
PBSC protruding 4-inches into mainline 46.7 LF from MH 56.

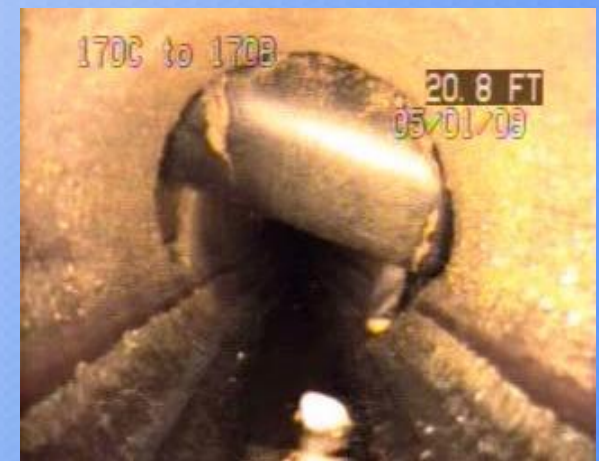
MH 170C to 170B – Avenue of Memories
View of unknown utility pipe crossing through sanitary sewer 22 LF from MH 170C.

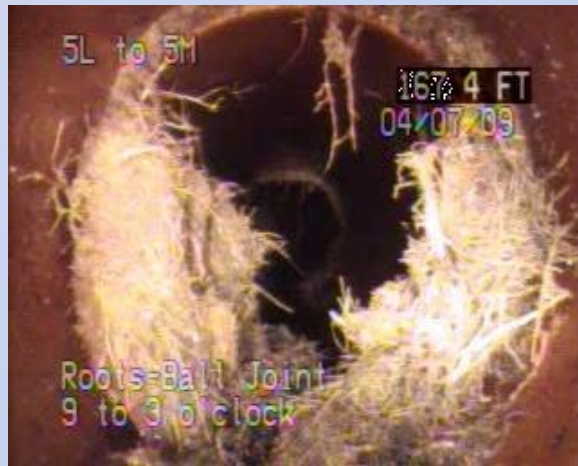
Charles Wood: MH 5M to 5L – Megill Drive
Joint with 30% root mass (indication of leak)
167.4 LF from MH 5L.

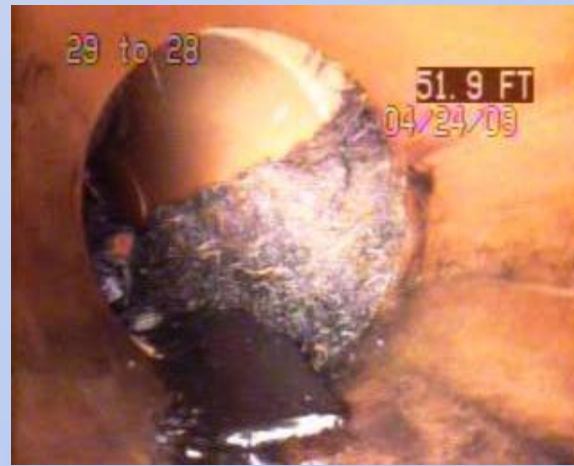
Charles Wood: MH 29 to 28 – BLDG 2700
Joint with 35% root mass (indication of leak)
54.7 LF from MH 29.

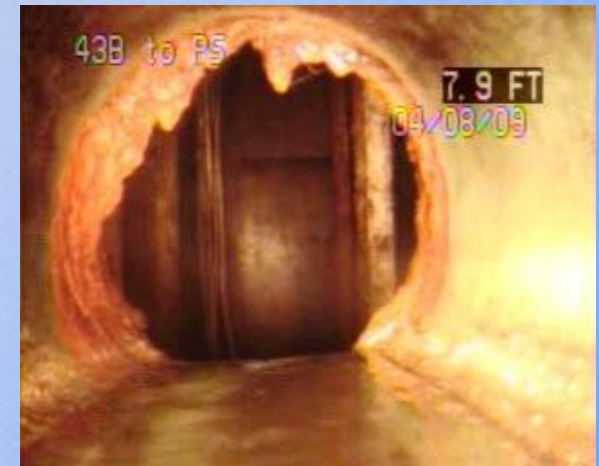
Charles Wood: MH PS – Hemphill Road
Sleeve leak at influent pipe (150 gpd).

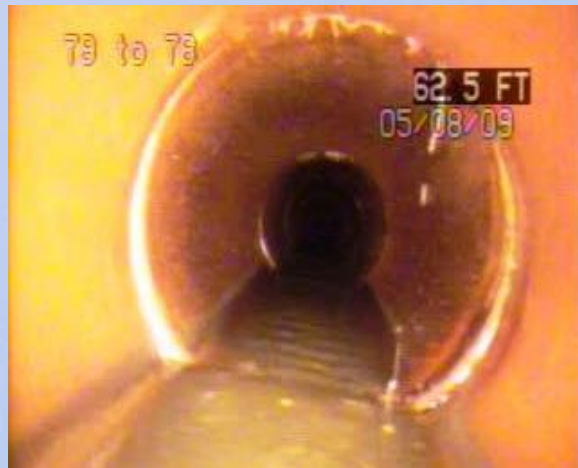
Main Post: MH 79 to 78 – Easement
Estimated 150 gpd from joint 64 LF from
MH 79.

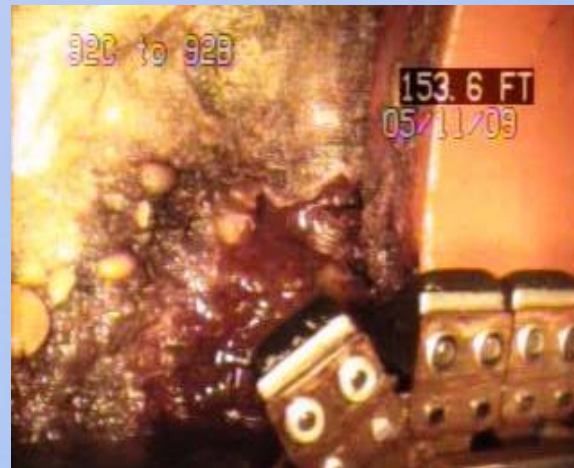
Main Post: MH 92B – Alexander Avenue
Sleeve leak at influent pipe (720 gpd).

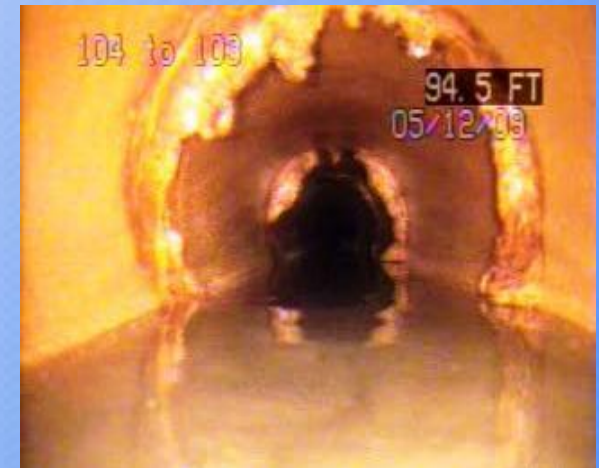
Main Post: MH 104 to 103 – BLDG 702
View of intermittent joints with mineral
deposits.

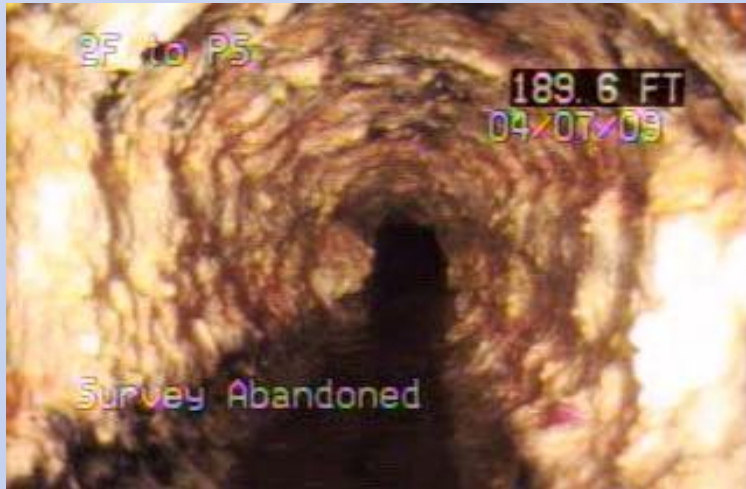
Charles Wood: MH 2F to PS - Club House Area
Grease accumulation (25%) 189.6 LF from MH 2F.

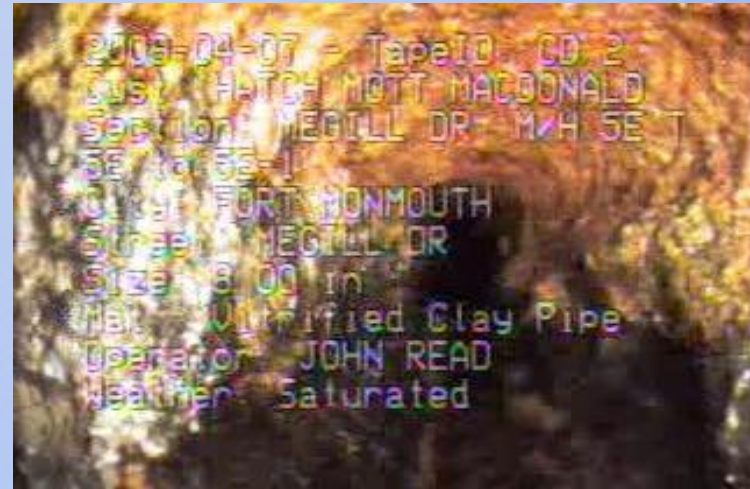
Charles Wood: MH 5E-1 to 5E – Megill Circle
Heavy tuberculation throughout sewer.

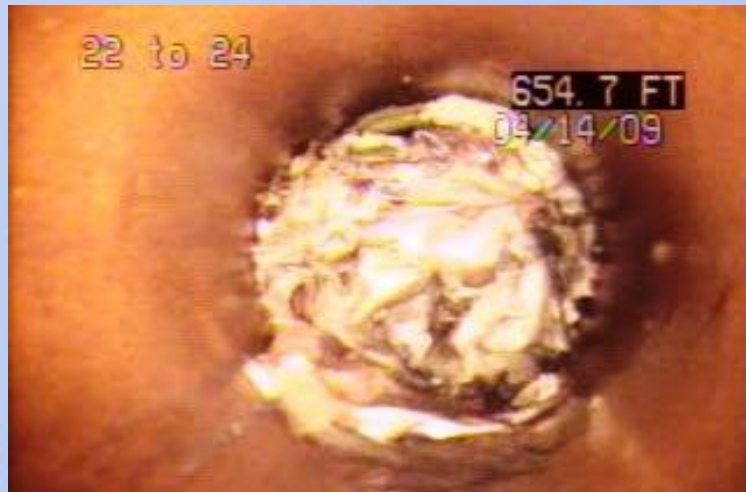
Charles Wood: MH 24 to MH 22 – Radiac Way
Larger paper accumulation 655 LF from MH 22.

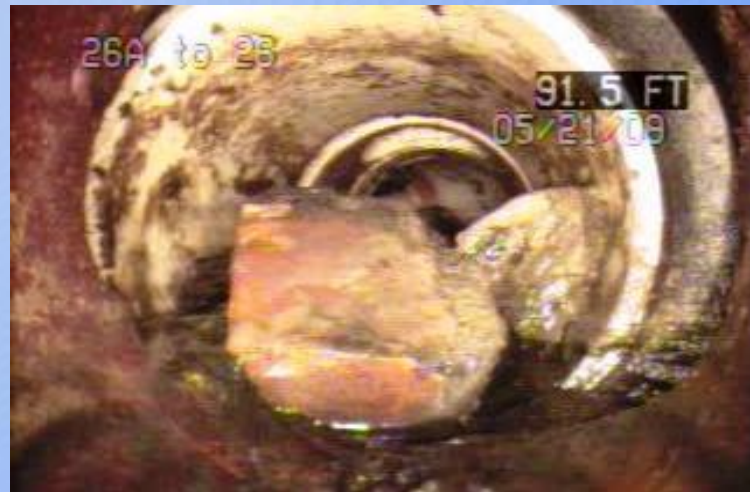
Main Post: MH 26A to MH 26 - Alley
Rocks stuck in PBSC 91.5 LF from MH 26A.

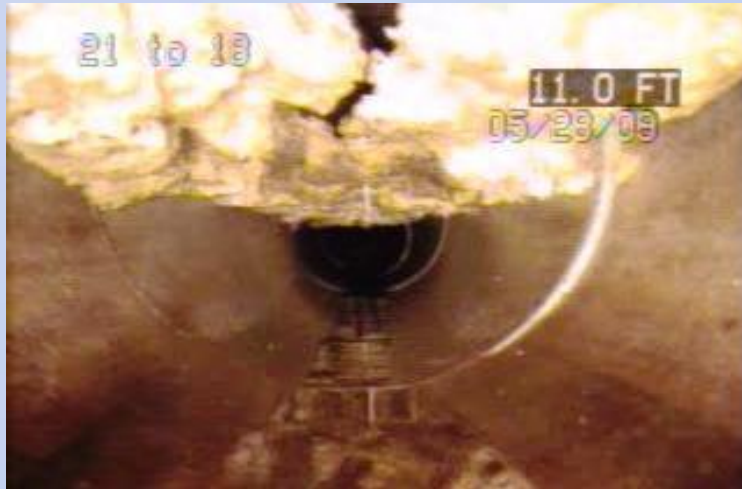
Main Post: MH 21 to MH 18 – 1st Avenue
Grease accumulation (30%) along pipe crown.

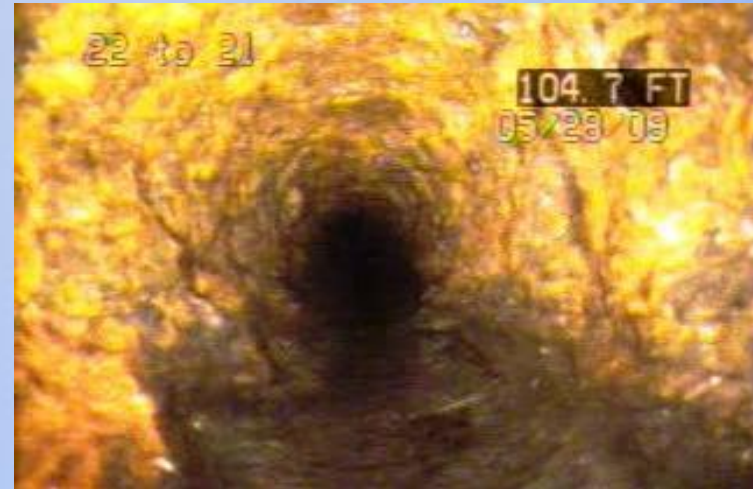
Main Post: MH 22 to MH 21 – 1st Avenue
Heavy tuberculation 103.6 to 129 LF from MH 22.

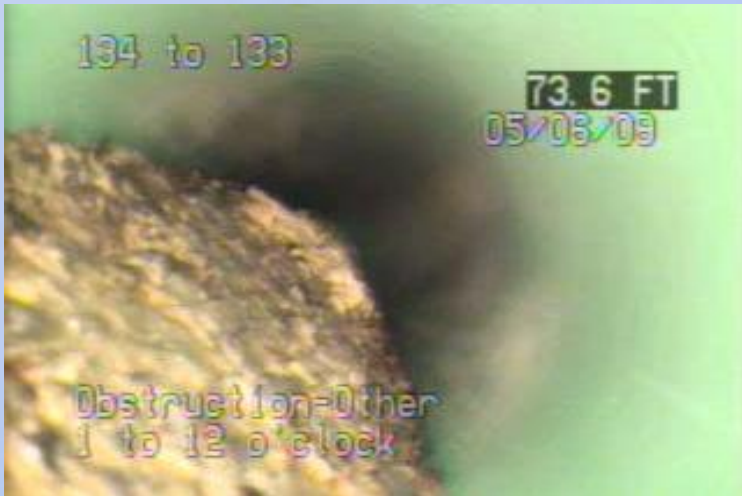
Main Post: MH 134 to MH 133 – Battery Ave. Easement
View of sediment/debris accumulation.

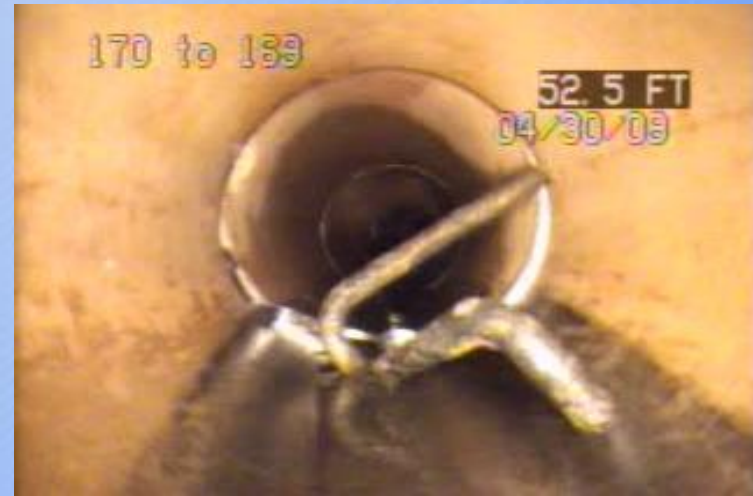
Main Post: MH 170 to MH 169 – Derum Avenue
View of manhole run stuck in pipe.
