Fort Monmouth Economic Revitalization Planning Authority

Sanitary Sewer System Evaluation – Draft Final Report

Wednesday, August 19, 2009

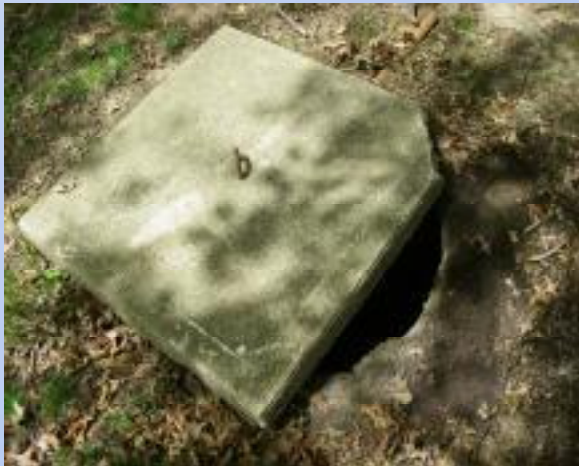
Main Post – MH 15A (Barkers Circle)
View of concrete slab placed over manhole; no frame or rim on manhole. HMM unable to remove slab.

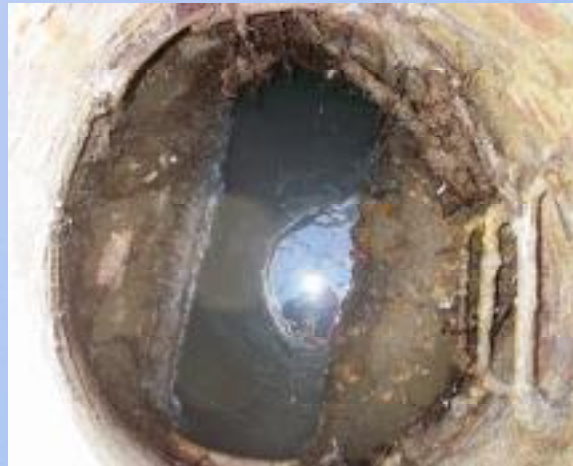
Main Post – MH 68 (Parkers Creek ROW)
View of large root throughout manhole protruding from lower wall.

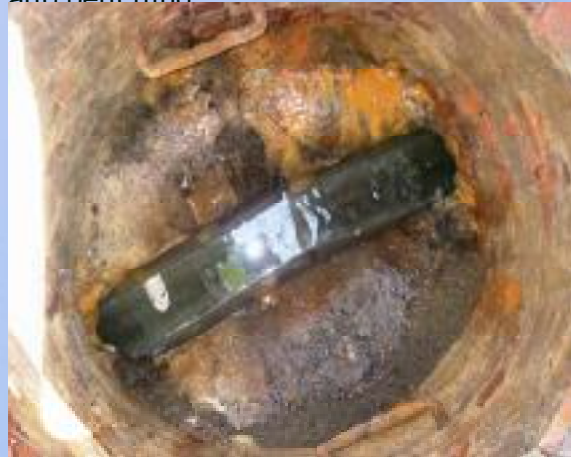
Main Post – MH 21 (Barkers Circle)
Estimated 2 gpm (3,000 gpd) from sleeve of effluent pipe, benching, and wall and bench junction.

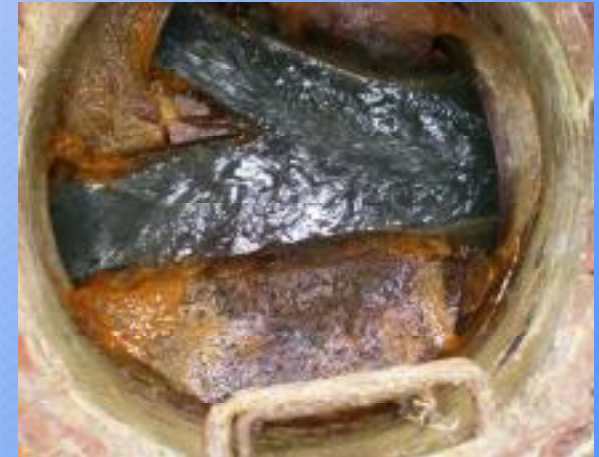
Main Post – MH 59 (Allen Court)
Estimated 1 gpm (1,500 gpd) from the sleeves of both influent pipes.

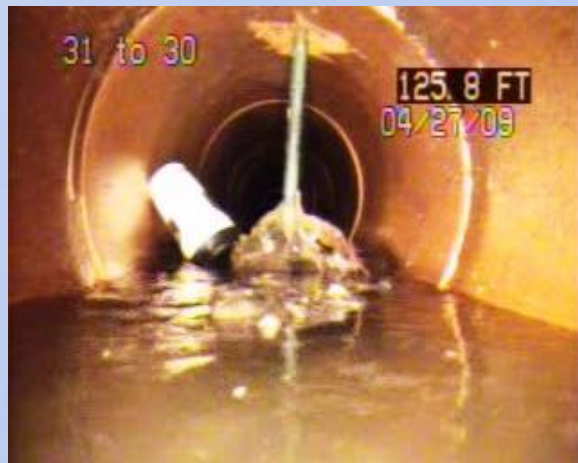
MH 31 to 30 – BLDG 2700 Easement
View of metal bar protruding through mainline 128 LF from MH 30 trapping debris.

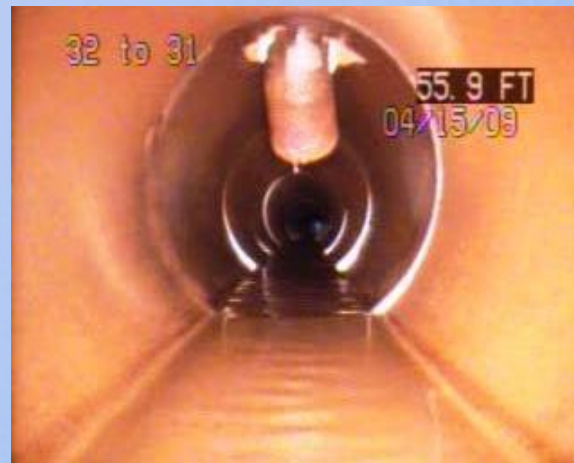
MH 32 to 31 – BLDG 2700
PBSC protruding 6-inches into mainline 60.4 LF from MH 32.

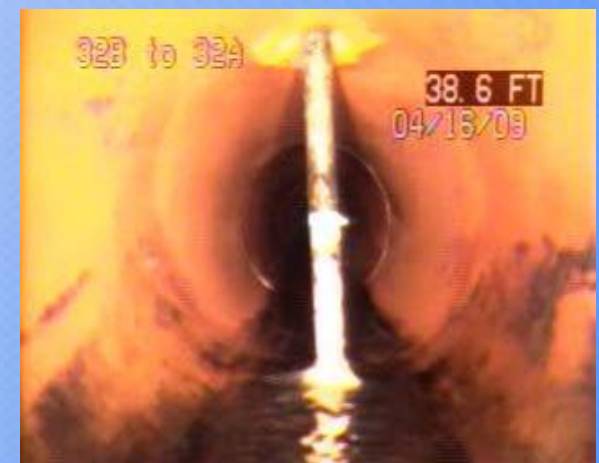
MH 32B to 32A – BLDG 2700
View of metal bar protruding through mainline 39.9 LF from MH 32B.

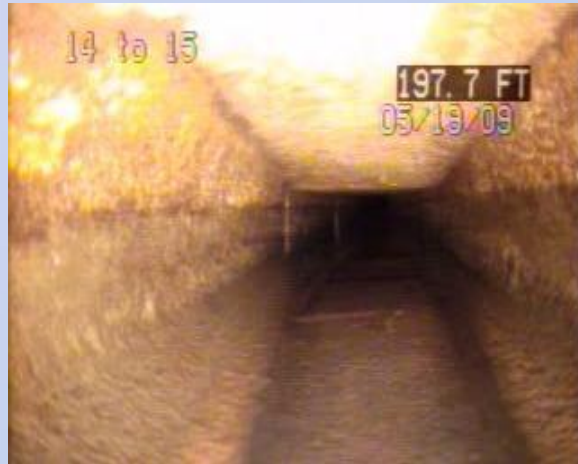
MH 14 to 15 – BLDG 208 Easement
Pipe changes shape from circular to rectangular 197.3 to 212.3 LF from MH 15.

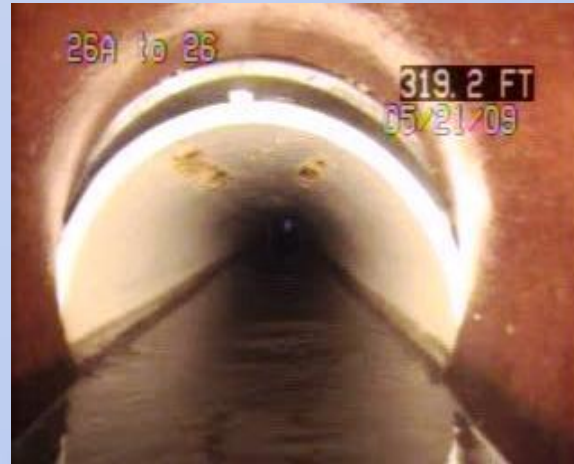
MH 26 A to 26 – Alley
View of camera entering 50% pipe sag due to offset joint 320.3 LF from MH 26A.

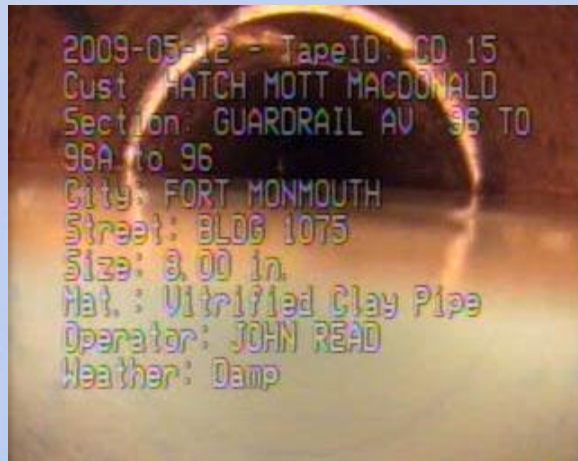
MH 96A to 96 – BLDG 1075
View of 50% sag from MH 96A to 15.1 LF downstream.

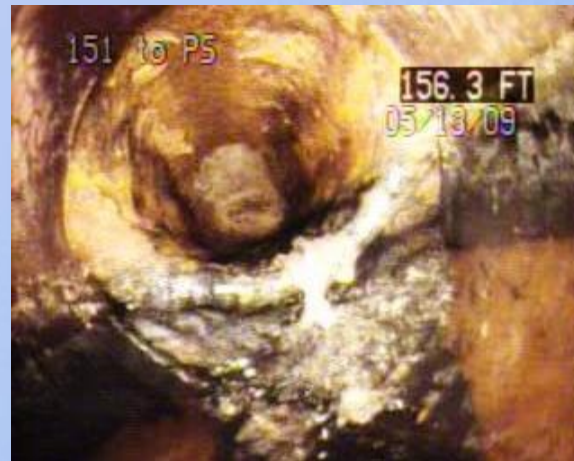
MH 151 to PS – Avenue of Memories
View of pipe offset 6-inches at pipe material change junction 159.2 LF from MH 151.
