Fort Monmouth Economic Revitalization Planning Authority

Sanitary Sewer System Evaluation – Draft Final Report

Wednesday, August 19, 2009

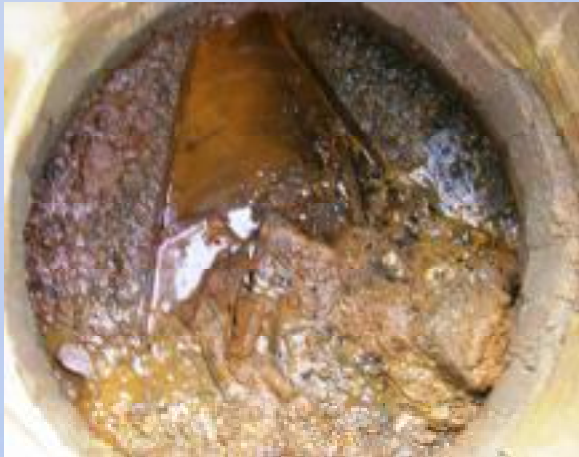
Main Post – MH 9E (Riverside Avenue)
Estimated 2 gpm (3,000 gpd) from caps of both pipes.

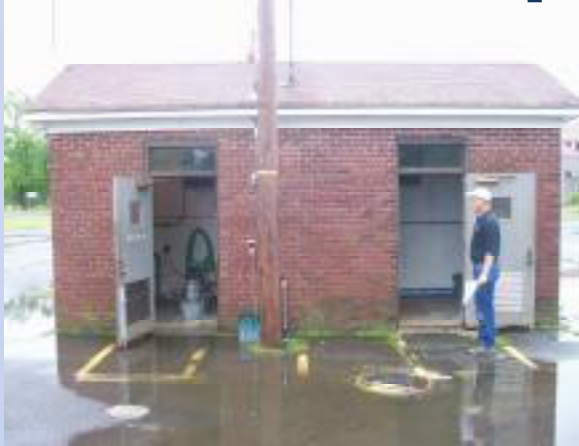
Main Post - PS No. 491

Located in the parking lot to the southwest of the Visitor's Center (behind bank).

- **PS 400** – Re-utilize existing PS and force main. Rehabilitate as recommended.
- **PS 491** - Existing PS is in conflict with redevelopment. Demolish existing PS and sewers. Construct new sewer system.
- **PS 257** – Re-utilize existing PS, FM and gravity sewers. Rehabilitate as recommended. Confirm capacity w/ Final Redevelopment Plans.
- **Gravity** - Hotel/spa should re-utilize existing 8” gravity sewer upon rehabilitation.

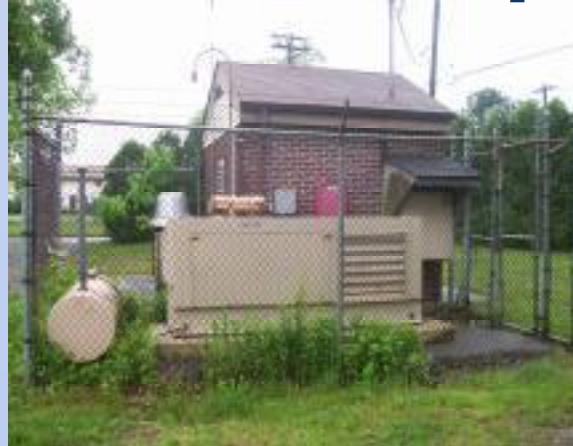
Main Post - PS No. 400

Located at the northeast corner of Oceanport Avenue and Hazen Street.

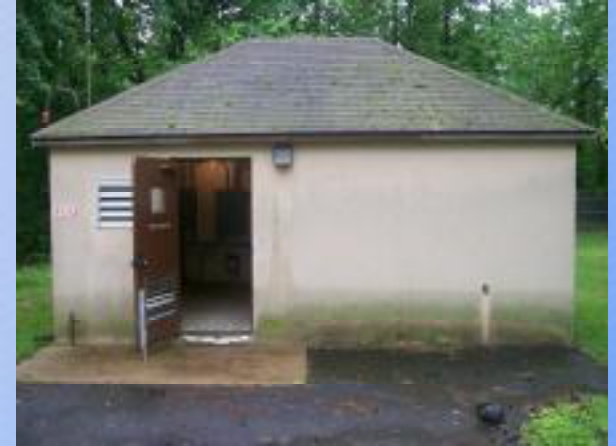
Main Post - PS No. 257

Located off of Riverside Avenue opposite Buildings No. 275 and No. T580.

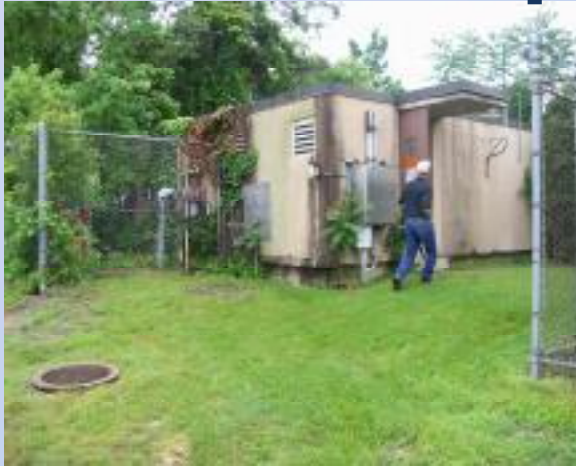
Main Post - PS No. 1221

Located at the corner of Avenue of Memories and Wilson Avenue.

- Ex. PS 1221 is in poor condition
- Ex. 18" main sewer is oversized
- Ex. Discharge needs to be disconnected from Oceanport system.
- Redevelopment concept shows many new buildings
- Recommend new gravity sewer with direct connection to ex. Eatontown Mill Brook Interceptor. Abandon PS and gravity system.

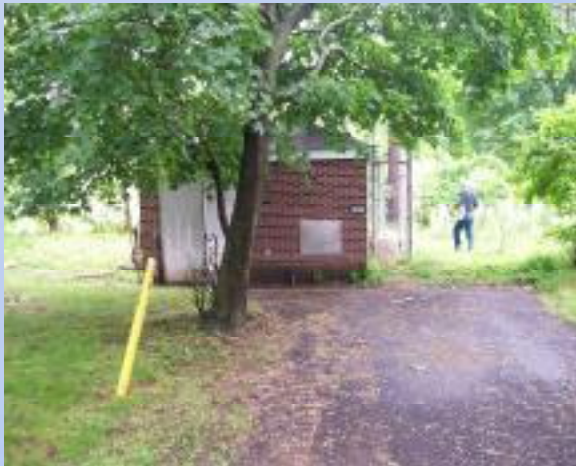
Charles Wood - PS No. 2043

Located off of Megill Drive on perimeter of Suneagles Golf Course.

- PS2043 (Pinebrook Housing) – Abandon existing gravity and PS system. Construct new to meet redevelopment. Connect into ex. Eatontown sewers.
- PS2012A (Gibbs Hall) – Maintain sewer system, rehabilitate PS and sewers as recommended.
- PS 2603 (Officer Housing) – Abandon PS, construction new PS with Hotel/Conference Center construction.
- TRWRA Connection – Investigate connection of new PS 2603 with TRWRA sewer near Bldg 2044. Construct new meter station.
